**Flood Control Project Maintenance
Levee Inspections**

Fall 2013 Levee Maintenance Deficiency Summary Report

**Flood Control Project Maintenance
Levee Inspections
Unit Cover Sheet
Fall 2013 Levee Inspection Results
Eastern Honcut Creek**

Eastern Honcut Creek

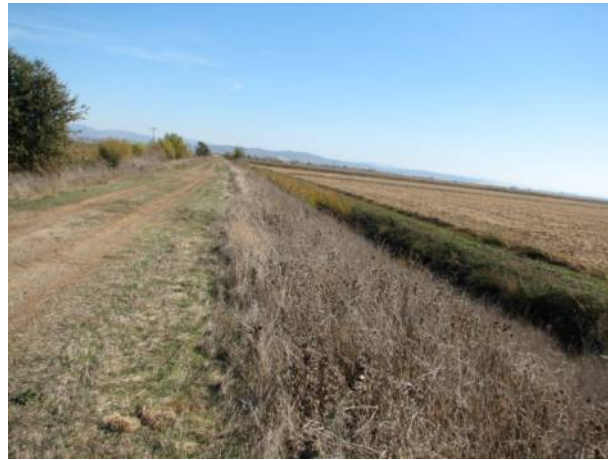
Levee Mile Report Line	4
Start Levee Mile	0.01
End Levee Mile	1.50
Location	Land Side
Category	Earthen Levee
Item	Vegetation

This photo shows the landside of the levee at levee mile 0.10.

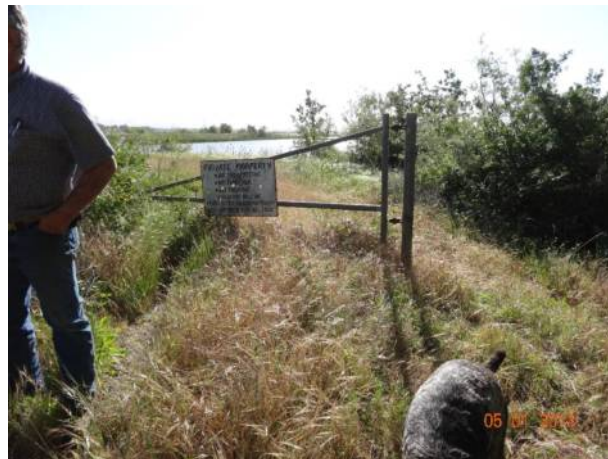
Levee Mile Report Line	5
Start Levee Mile	0.01
End Levee Mile	0.01
Location	Land Side
Category	Supplemental
Item	DWR UCIP Field Study

View of crown looking east.

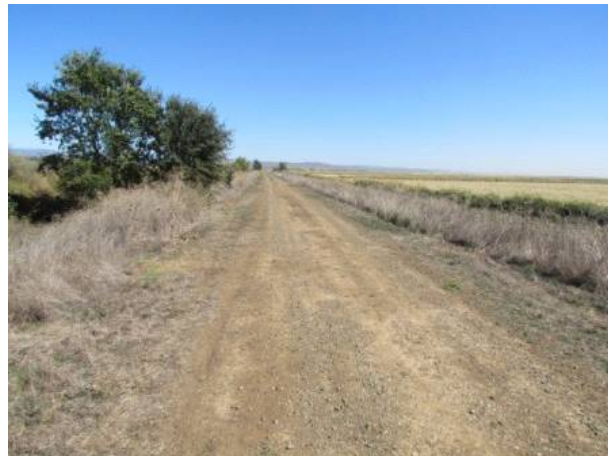
Levee Mile Report Line	7
Start Levee Mile	0.05
End Levee Mile	1.50
Location	Water Side
Category	Earthen Levee
Item	Vegetation

This photo was taken from the levee crown facing east looking at the vegetation on both the landward and waterward levee slopes.

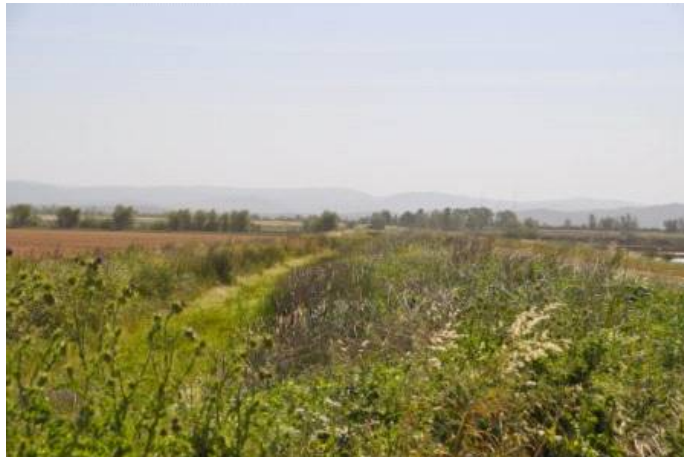
Levee Mile Report Line	10
Start Levee Mile	0.66
End Levee Mile	1.19
Location	Water Side
Category	Earthen Levee
Item	Encroachments

Toe ditch parallel to levee @ w/s toe. Heavy vegetation in ditch.

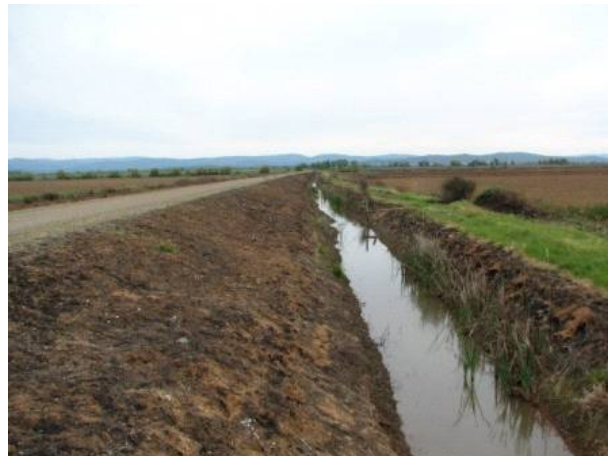
Levee Mile Report Line	11
Start Levee Mile	0.68
End Levee Mile	1.46
Location	Land Side
Category	Earthen Levee
Item	Encroachments

Levee mile 0.85, this photo is looking upstream at a ditch on the landside toe.

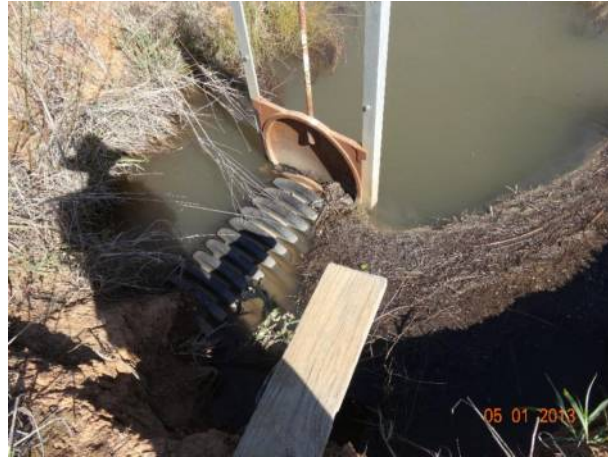
Levee Mile Report Line	12
Start Levee Mile	1.00
End Levee Mile	1.00
Location	Land Side
Category	Supplemental
Item	DWR UCIP Field Study

Positive closure device on waterward side.

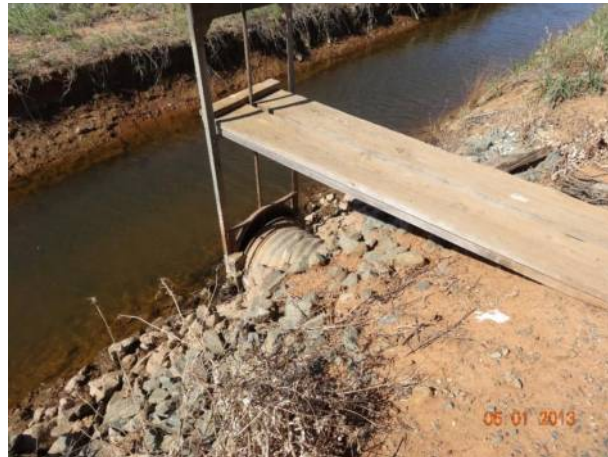
Levee Mile Report Line	13
Start Levee Mile	1.19
End Levee Mile	1.19
Location	Land Side
Category	Supplemental
Item	DWR UCIP Field Study

LMR No.	Levee Mile		Category	Item	* Location	** Rating	Action/Comment	GPS Latitude/Longitude		Issue No. Photo
	Start	End						Start	End	
13	1.19	1.19	Supplemental	DWR UCIP Field Study	LS	M En	Inspector Comments: FS_ID:14734 EP_NO: N/A Repair Type: Non-Urgent Crossing Status: Found UCIP Comments: Recent repair will need to contact owner to follow-up. FIELD_STRUCT_DESC: 24-inch corrugated metal pipe through the level 10 feet below the crown. Flapgate on waterward side. FS Date: 5/1/2013	39.295099 ° 39.295099 °	-121.551839 ° -121.551839 °	15 Y
DWR ID: DWR_NA0006_01_f_2013_15										
14	1.47	1.47	Supplemental	DWR UCIP Field Study	LS	M En	Inspector Comments: FS_ID:14736 EP_NO: N/A Repair Type: Non-Urgent Crossing Status: Found UCIP Comments: Need to determine permit authorizing work. FIELD_STRUCT_DESC: 18-inch corrugated metal pipe through the levee 8 feet below the crown. Slide gate on the landward end. Shot rock revetment on the landside near slide-gate. FS Date: 5/1/2013	39.295238 ° 39.295238 °	-121.546755 ° -121.546755 °	16 Y

View of landward side: positive closure device, walkway, and rip rap on slope.

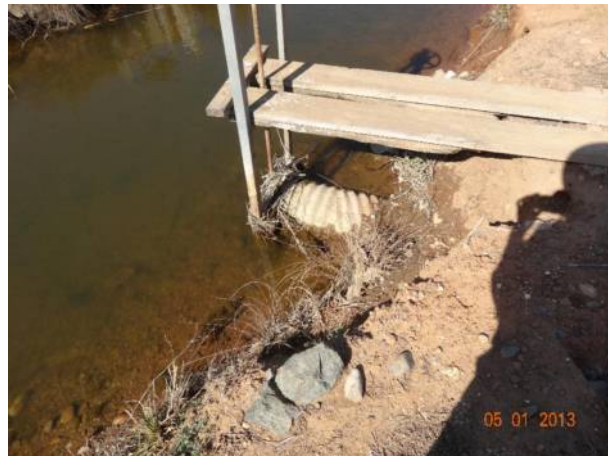
Levee Mile Report Line	14
Start Levee Mile	1.47
End Levee Mile	1.47
Location	Land Side
Category	Supplemental
Item	DWR UCIP Field Study

Walkway and positive closure device located on landward side.
